Manhole Inspection Summary

Manhole # S21GG2011MH

Insp Date: **11/9/06 2:05 PM**

Location Address: **1109 HARRITON RD**

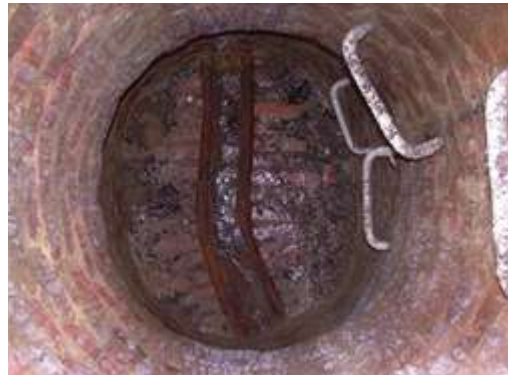
Top View

Evidence of surcharge - Bench debris.

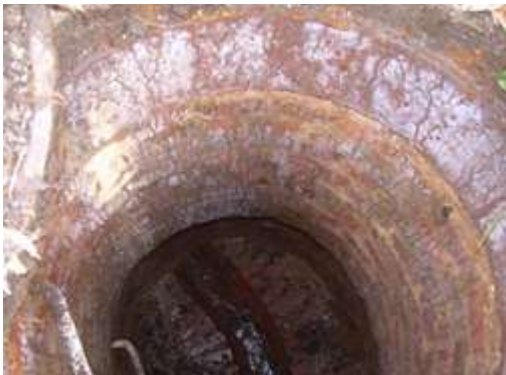
Defect

Frame leaks. Adjustment deterioration, root intrusion and infiltration. Barrel infiltration.

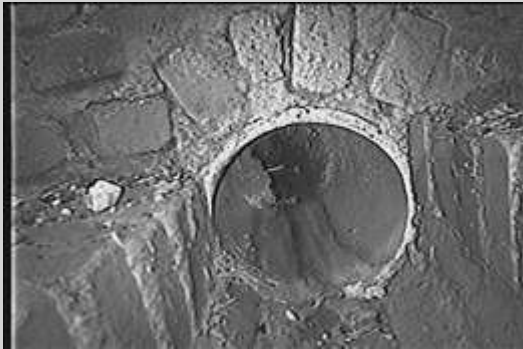
Pipe Out @ 12 O'Clock

Barrel deterioration and infiltration. Channel root intrusion.

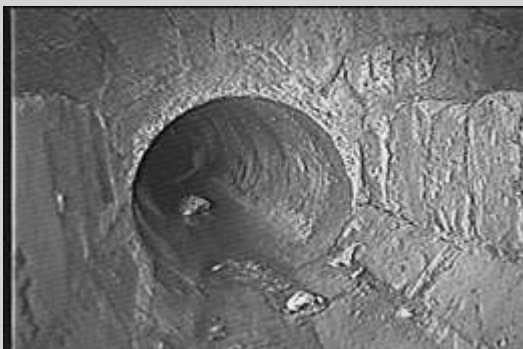
Pipe In @ 5 O'Clock

Channel deterioration.
